# NATIONAL TRANSPORTATION SAFETY BOARD

## RAILROAD ACCIDENT REPORT

DERAILMENT OF  
SOUTHEASTERN PENNSYLVANIA  
TRANSPORTATION AUTHORITY (SEPTA)  
COMMUTER TRAIN 61  
PHILADELPHIA, PENNSYLVANIA  
MARCH 7, 1990

**Abstract:** This report explains the derailment of Southeastern Pennsylvania Transportation Authority (SEPTA) commuter train 61 in Philadelphia, Pennsylvania, on March 7, 1990. The safety issues discussed in the report are mechanical inspection procedures and maintenance practice oversight, supervision and training of SEPTA employees responsible for transit equipment, failure of the motor support bolt assembly, Federal and State regulatory requirements for mass transit operating practices and mechanical equipment inspectors, effectiveness of SEPTA's drug and alcohol testing program, and emergency communication between operating crews, tower personnel, and emergency response personnel. Recommendations concerning these issues were made to SEPTA, the Governor of Pennsylvania, the Transport Workers Union, and the City of Philadelphia Fire Department.

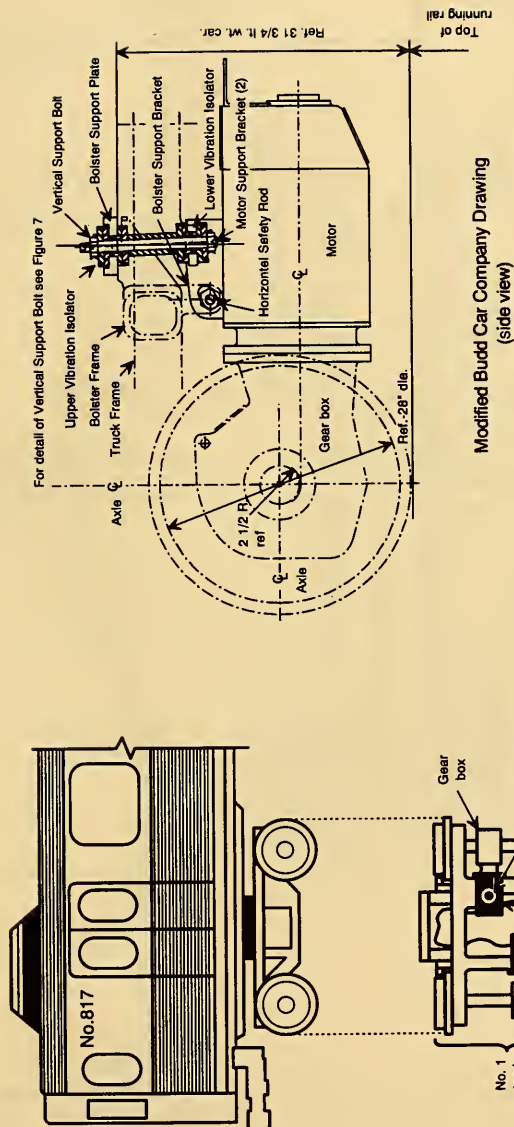
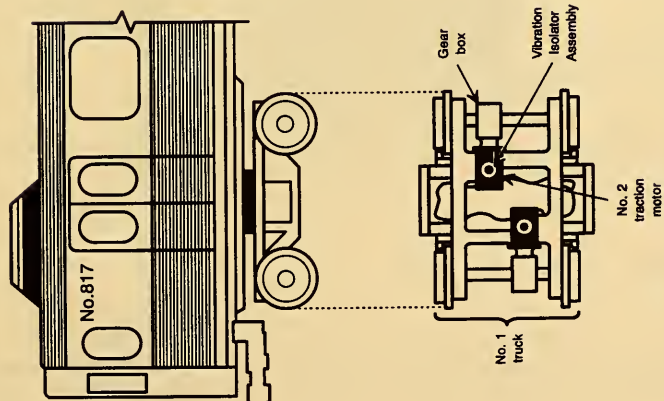
Figure 5.--Truck assembly and traction motor support attachment to truck assembly.

**Safety Rod and Traction Motor Support Brackets.**--The shank of the horizontal safety rod was extensively worn in two spots. On assembly, the two spots corresponded to the positions of the two vertical members of the motor support brackets. (See figure 5.)

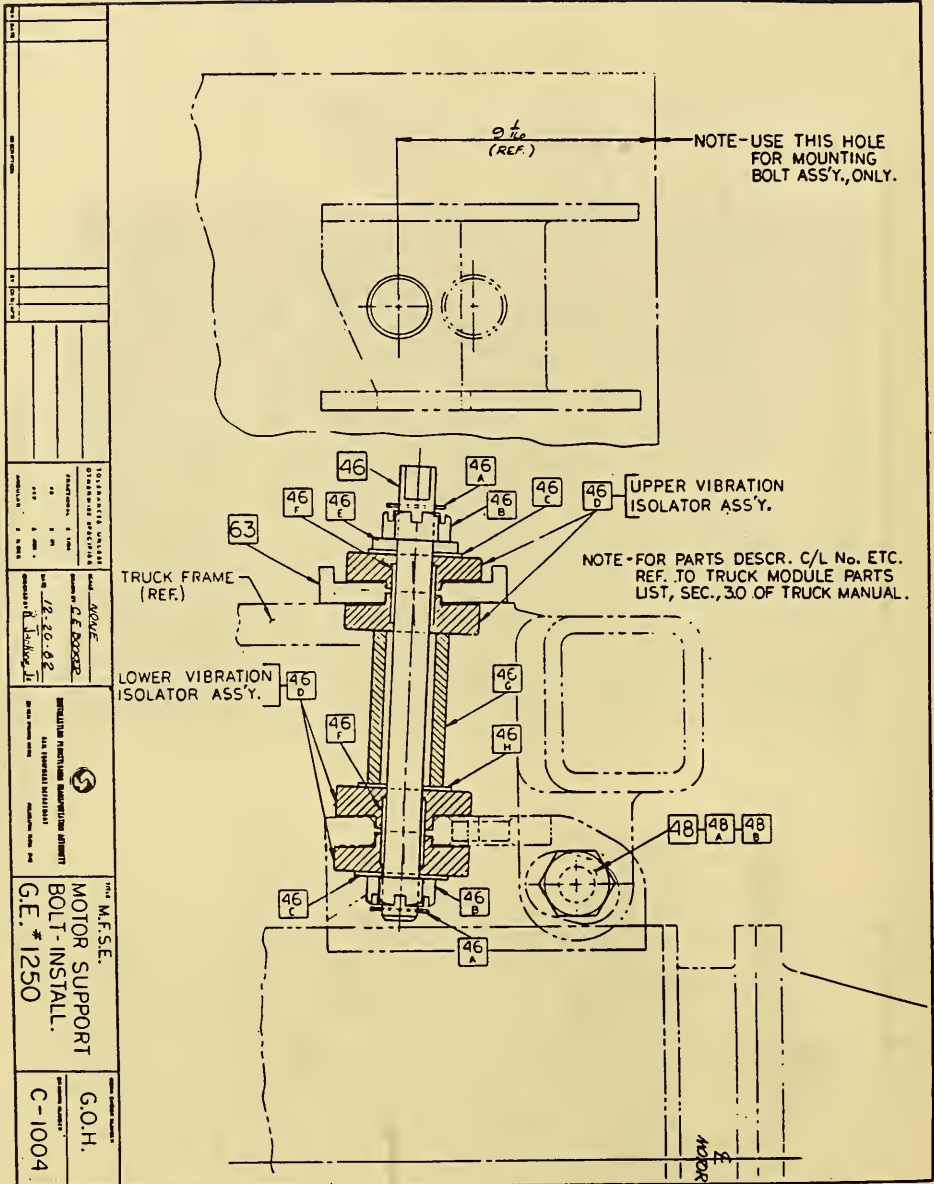
When the Safety Board reviewed SEPTA mechanical drawing No. C-1004 (see figure 6), it found that the upper part of No. 46F was a shorter metal sleeve than was the sleeve in the lower part of No. 46F. However, the drawing showed no washer between the lower half of the upper vibration isolator assembly (46D) and the metal sleeve between the upper and lower isolator assemblies (46G). This is in conflict with the Budd Car Company's original drawing in which a washer was shown at this location. (See figure 7.) Safety Board investigators found that both the upper and lower metal sleeves on the vertical support bolt from car 817 were 2 inches long, and SEPTA officials testified that 2-inch sleeves had been used for both the upper and lower vibration isolator assemblies for as long as they could remember.

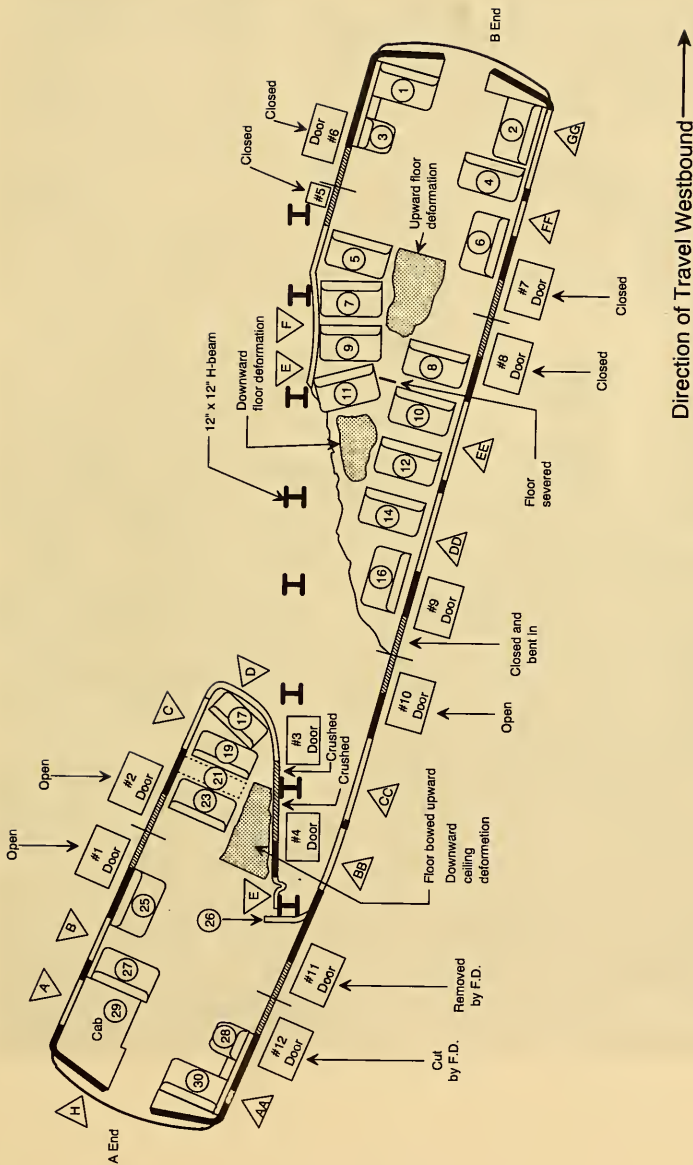
**Figure 8.--Damage profile of car 818.**

The first three cars (769, 770, and 817) were not derailed. The fourth car (818) derailed in the crossover between the eastbound and the westbound tracks. The lead truck wheels of the sixth car (725) were derailed in the crossover on the westbound track. This car's rear truck wheels were on the closure rails of the turnout. The fifth car (726) was derailed in the crossover. The left side of car 818 (the fourth car) collided with steel 12-inch by 12-inch H beam uprights that were 165 feet west of switch 7E. The car's body was sheared open for 30 feet and was almost severed near the midpoint. (See figures 8 and 9.)

The ceiling panels of car 818 had several cracks between the B end and the first vent fan. The ceiling between the first and second fan had cracks on the right panel. The left panel was missing. Insulation and roof structure were hanging into the
